## Certificate of attendance and completion

***Assessment of the roof structure of St. Michaels  
church in Vienna.***

# Assessment of the roof structure of the St. Michaels church in Vienna

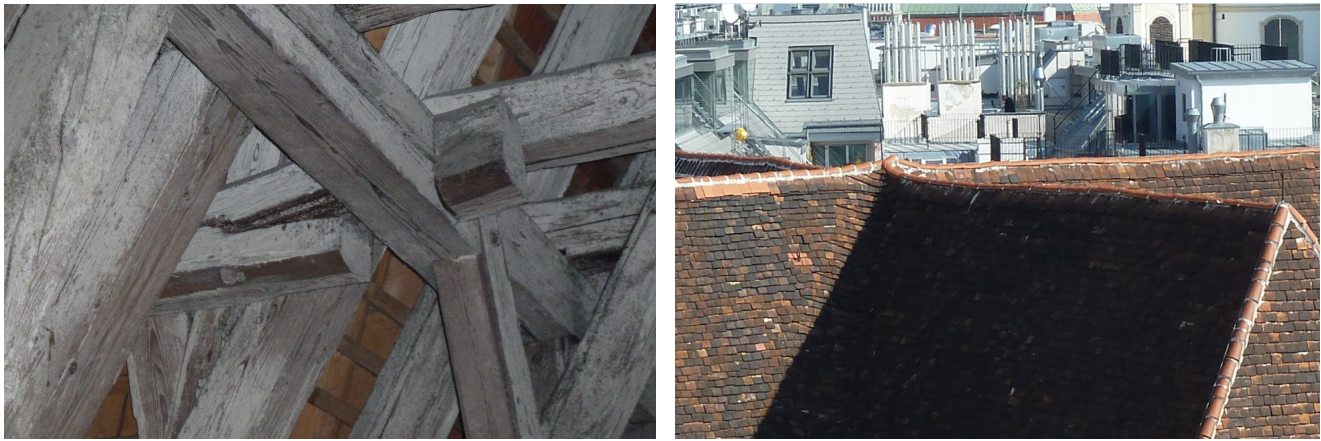
Fig. 9. Longitudinal crack in the notched head runner (left), and deflection of the transept apex (right) at the crossing nave - transept.

During the visual inspection, two areas of moisture stains have been identified. After the timber moisture content has been checked (see Section 3.3), it was clear that this moisture stains are of older date (the timber was dry). It was difficult to identify the usually white colored wet areas, since most elements of the roof structure are covered by some kind of white lime slurry, added decades ago to increase fire resistance of these timber elements (e.g. Figure 9 - left).

The main two defects of this timber roof are related to the crossing of the nave and transept part of the structure. On the one hand, a massive crack in the notched head runner of the transept at the connection to the nave has been identified (see Figure 9 - left). This crack can be found at each of the four head runners, which indicates a structural problem. Close related to the first problem is the second one, which are high deflections of the transept apex in the crossing area nave - transept. The structural analysis attempts to explain these two defects (see Section 3.5).

Beside this serviceability issue of large deflections at the crossing transept-nave, this weak point in the design also causes problems in the load bearing behavior of the structure. All four head runners of the transept exhibit massive cracks in longitudinal direction of this beams at the connection to the nave roof structure. The deflections extracted from the structural analysis confirm, that the head runners exhibit remarkable relative displacements related to the head runners of the nave. The connection in the head runners of the transept have not been able to carry this large relative displacements, which leads to failure of the connection by means of longitudinal cracks at the notches of the timber beams. Verification of this connection, based on EC5 [4] including the shear-forces from the structural analysis, confirms the detected failure.

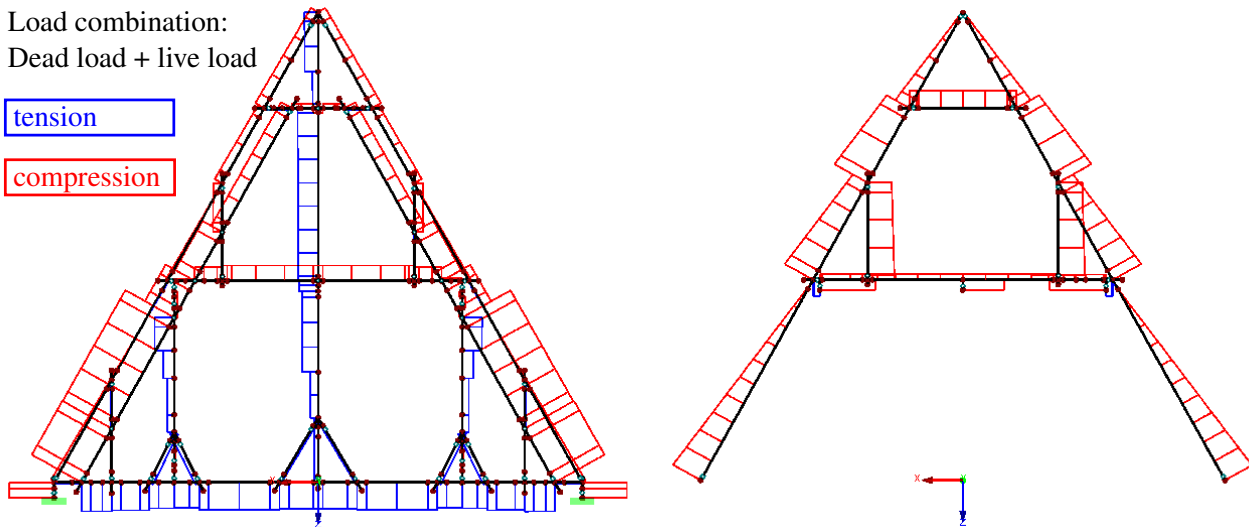
In Figure 10 - left, the distribution of the normal forces within the main rafters is shown. The normal forces presented here are caused by symmetric loading (consisting of dead load and live load). The normal forces marked in red color are related to normal forces in compression, the blue one to tension, respectively. This definition is valid for all normal force distributions presented in this work. In historic roof structures the distribution of the normal forces is a good indicator for the load bearing behavior of the structure.

Fig. 10. Normal forces of the main rafters (left) and intermediate rafters (right) under the load combination dead load and live load.

The intermediate rafters (see Figure 10 - right), located between the main rafters, is mainly loaded in compression, since the elements to carry tensional forces are missing. In this case, the loads, which cause tension in the structure, are transferred by the elements in longitudinal direction of the roof structure to the main rafters. The elevating belts, responsible for the stability of the structure in longitudinal direction, located at the level of the queen posts and king posts are mainly loaded by normal forces in tension and compression.

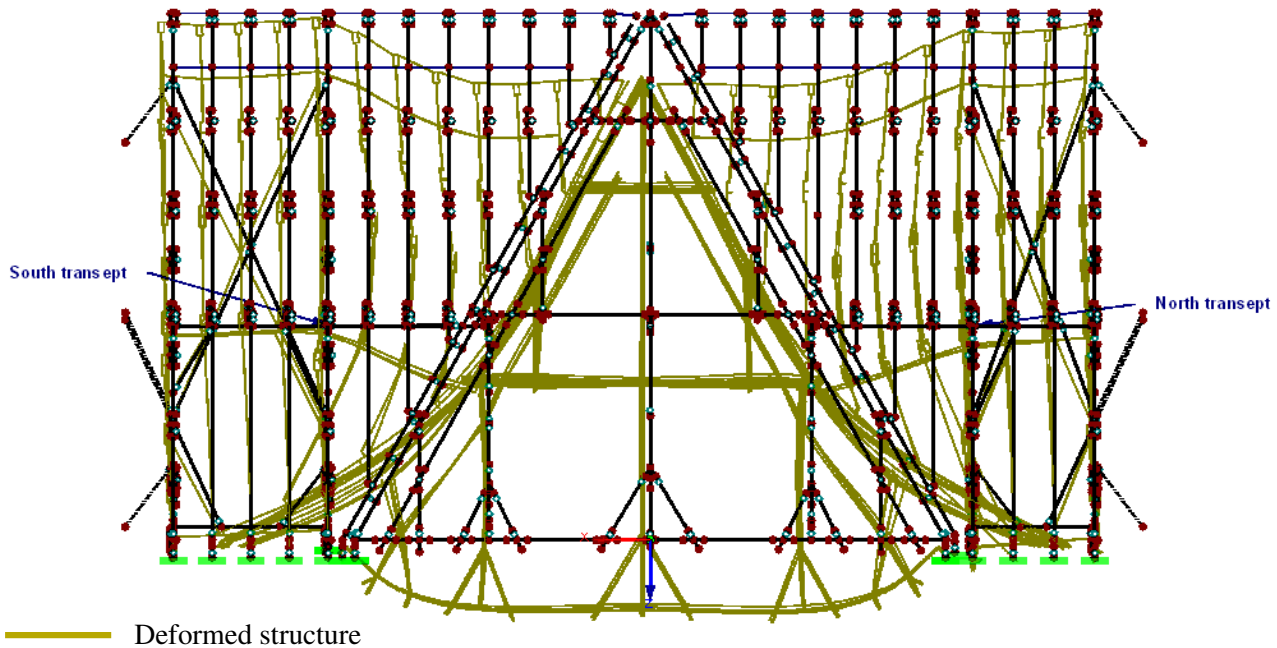
Fig. 11. Global deformation of the crossing nave-transept under the load combination dead load and live load.

First, the deflections in the transept are discussed, which have been detected by on-site visits. It is distinguished between the northern and southern part of the transept, since the execution of the structural system deviates from each other. For both, the northern and southern transept, compliance in axial direction ( $\Delta u_x$ ) and transverse direction ( $\Delta u_z$ ) for the connection between transept rafter and the load spreading valley rafter are defined. Forces between this two elements are exclusively transferred, by means of friction. The bearing capacity of the slender forged steel nail has been neglected. This kind of load transfer goes hand in hand with large deformation. In simple terms, the rafters slide downwards the load spreading valley rafter under vertical loading. In other words, relative displacements between the rafters of the transept and the valley rafter are generated. This compliance of the connection between the transept rafters and the valley rafter, in combination with the vertical displacement of the load spreading valley rafter, caused by deflection of the nave roof structure, causes the settlement of this “wedge” in the transept roof between apex and the first main rafters, which can be seen on-site (see Figure 9 - left) and also from the result of the structural analysis (see Figure 11).

The difference in the deformed system between the southern part of the transept (Figure 11 - left part) and northern part of the (Figure 11 - right part) can be found in the bearing situation of the tie beam. The tie beam of the first main rafters at the southern transept rests on the outer walls, which is not the case for the northern part. This circumstances results in even higher deformations for the northern part and a softer transition between the highly deflected crossing part and the less deflected main transept part.

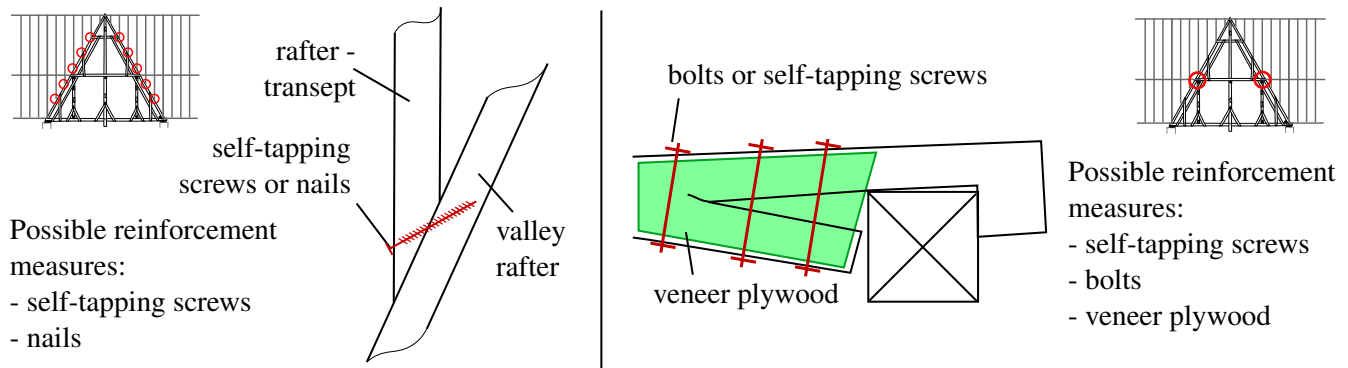
Fig. 12. Reinforcement measures for the connection transept rafter - valley rafter (left) and for the connection head runner transept - nave (right).

The only two defects, which may require reinforcement measures are related to the intersection nave - transept. This is on the one hand side the connection of the notched transept head runner to the nave head runner, which exhibits a massive longitudinal crack. On the other hand, high deflections in the transept part next to the intersection nave - transept may cause problems in the future. Since the root of both problems can be found in the weak connection between the nave and transept roof structure, strengthening the connection of these elements may avoid further damages in this area. The following reinforcement measures may be applicable:

This reinforcement action shall prevent the transept rafter from further sliding down along the load spreading valley rafter, in order to avoid an increase of the deflections in the transept roof structure, which may cause serviceability problems due to water intrusion. Possible reinforcement measures are to connect this two elements by self-tapping screws or nails, in order to transfer shear forces between the transept rafter and the valley rafter (see Figure 12 - left). In addition, this reinforcement action increases the position stability of the rafter.

Reinforcement measures at the head runner are addressed to prevent further cracking of this connection, in order to avoid stability and serviceability problems. Additional elements to carry tensional forces perpendicular to the grain have to be added. This elements may be self-tapping screws or bolts in transverse direction of the connection, or glued on engineered timber plates, like veneer plywood (see Figure 12 - right).
