## Certificate of attendance and completion

***Assessment of the roof structure of St. Michaels  
church in Vienna.***

# Assessment of the roof structure of the St. Michaels church in Vienna

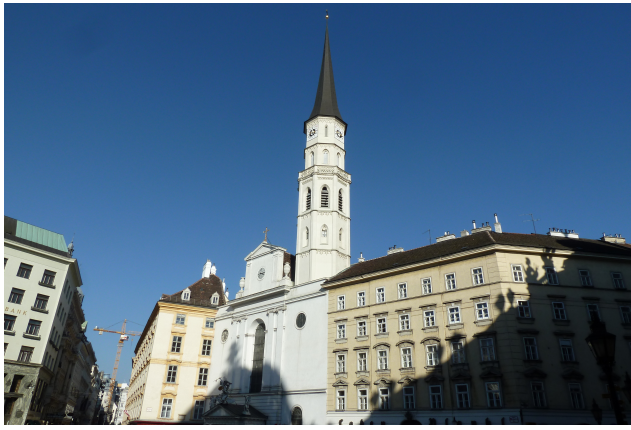
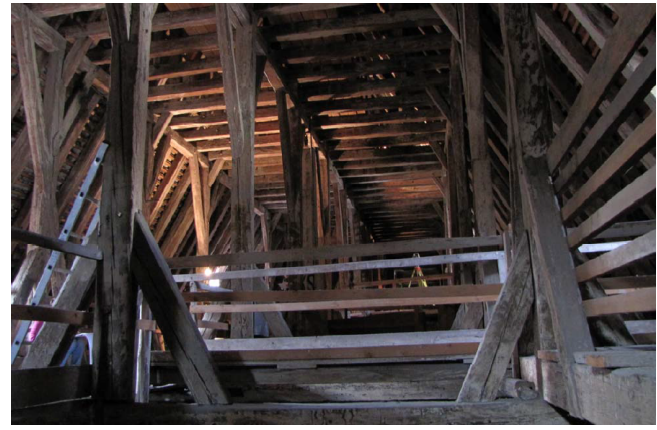
Fig. 1. View of the St. Michaels church (left), interior of the nave roof structure (right).

In general, the timber roof structure is in good condition, especially taking into account the age of the structure. The main purpose of this work is to understand the structural behavior of the timber roof, and to give a first statement on the reliability of the timber structure, including observed defects of the roof. The main pathology of this timber structure is addressed to the connection of the nave and transept roof part, where each of the four notched head runners of the transept exhibits massive cracks in longitudinal direction (see Figure 9 - left). Furthermore, large deflections of the transept apex can be seen (see Figure 9 - right). In addition, missing elements of the structure, which have been removed in the past to make the roof structure accessible, may affect the structural behavior. Furthermore, at some parts of the roof, moisture stains have been detected, which may indicate the possibility of water intrusion.
